Manhole Inspection Summary

Manhole # S06CC2008MH

Insp Date: **6/29/06 8:08 AM**

Location Address: **7004 FIELDCREST RD**

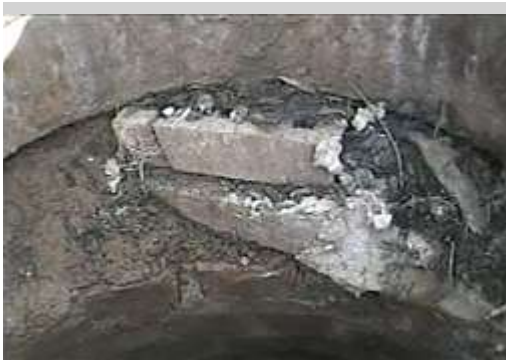
Defect

Frame Offset: **0** (in.) Condition: ☐ Sound ☐ Cracked ☒ **Leaks**

Condition: ☐ Sound ☐ Cracked ☐ Root Intrusion ☒ **Loose Brick** ☒ **Deteriorated**

Infiltration: ☐ None ☒ **Joint** ☐ Cracks ☒ **Mortar** ☐ Roots ☒ **Wall**

Frame leaks. Frame offset. Adjustment deterioration and infiltration.

Comments **There is very heavy infiltration in this MH - Regardless of its rating it should be rehabbed.**

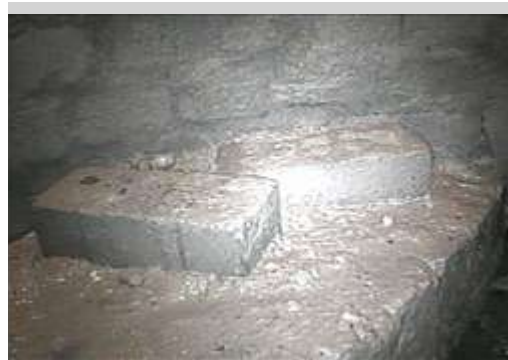
Defect

Bench ☒ Exists Material: **Brick** ☐ Parged ☒ **Debris** (not Condition related)

Bench debris.

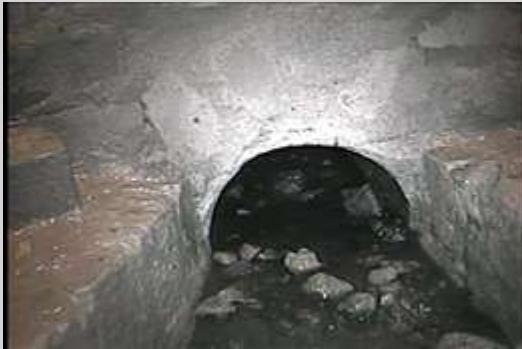
8 in. Circular Gravity Sewer Pipe Out @ 12 O'Clock

Heavy debris

Deposits: ☐ None ☒ **Mud** ☐ Sludge ☒ **Debris** ☐ Grease

Silt Depth: **3** (in.) Deposits Extent: **Medium**

Infiltration: **Evidence** Pipe Seal Cond: **Cracked**

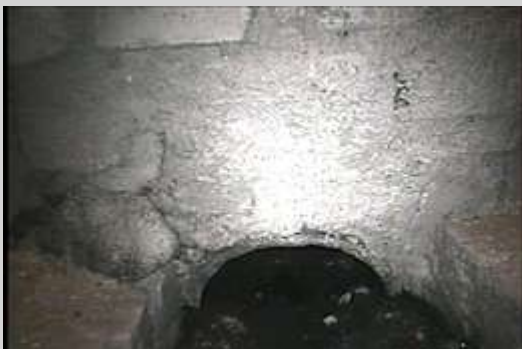
4 in. Circular Gravity Sewer Pipe In @ 8 O'Clock

Heavy debris

Deposits: ☐ None ☒ **Mud** ☐ Sludge ☒ **Debris** ☐ Grease

Silt Depth: **3** (in.) Deposits Extent: **Medium**
